Rehabilitation Plan

Stage 2 (Bald Hill) Gold Project

April 2012

Tanami Gold NL

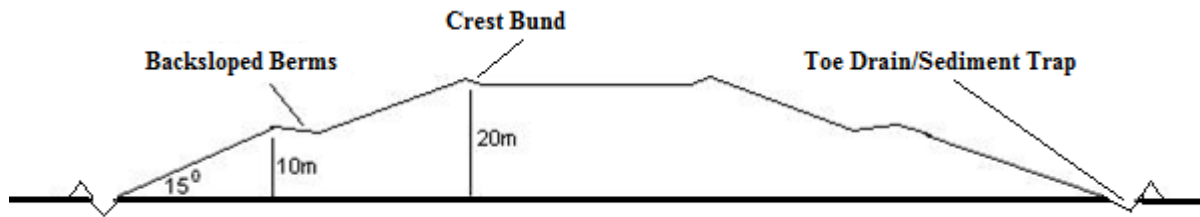
Figure 5 Waste Dump Design Concept

To ensure that erosion is minimised and stability is maximised TGNL will reduce the accumulation of runoff from rain events. The method involves reducing the amount and velocity of water moving over any given surface of the waste dump. **Figure 5** provides a conceptual plan for the Bald Hill waste dump.

Water on the top of the Bald Hill waste dump must be retained. To accommodate this, the waste dump top must be level, and be able to store incident rainfall. Crest bunds are required to control surface water on the dump top to ensure water does not discharge from the top to the batters. A 72 hour storm event with a return interval of 100 years would deliver ~350 mm of rain. Therefore, the crest bund should be at least 650 mm high (to allow for 300 mm freeboard). The crest bund must be shaped to discourage the pond of water near the crest bund as a means of limiting the risks associated with tunnel erosion. A schematic of the crest bund concept can be found in **Figure 6**.

Recent sampling of soils around from the waste dump and deposition areas around the waste dump has confirmed the assumptions that contaminates and acid forming substances are not impacting on the surrounding environment (see **Appendix C**). The retention dump design shown in **Figures 5 to 7** will help to reduce the potential for any contaminated surface water to enter the receiving environment.

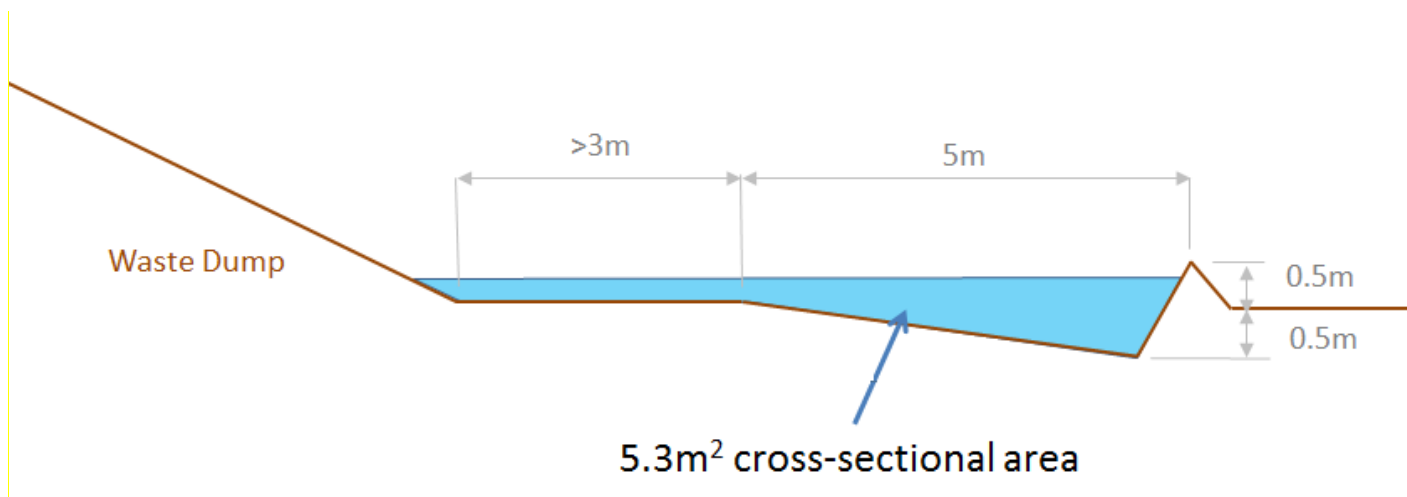
Figure 7 Toe Drain/Sediment Trap Design

The disturbance approved area around the toe of the waste dump will be constructed into a toe drain that acts as a final sediment trap. A cross-sectional capacity of 5.3 m² is predicted to store rainfall and eroded sediment and it incorporates infiltration estimates of a sandy, clay loam. The toe drain/sediment trap design can be found in **Figure 7**.

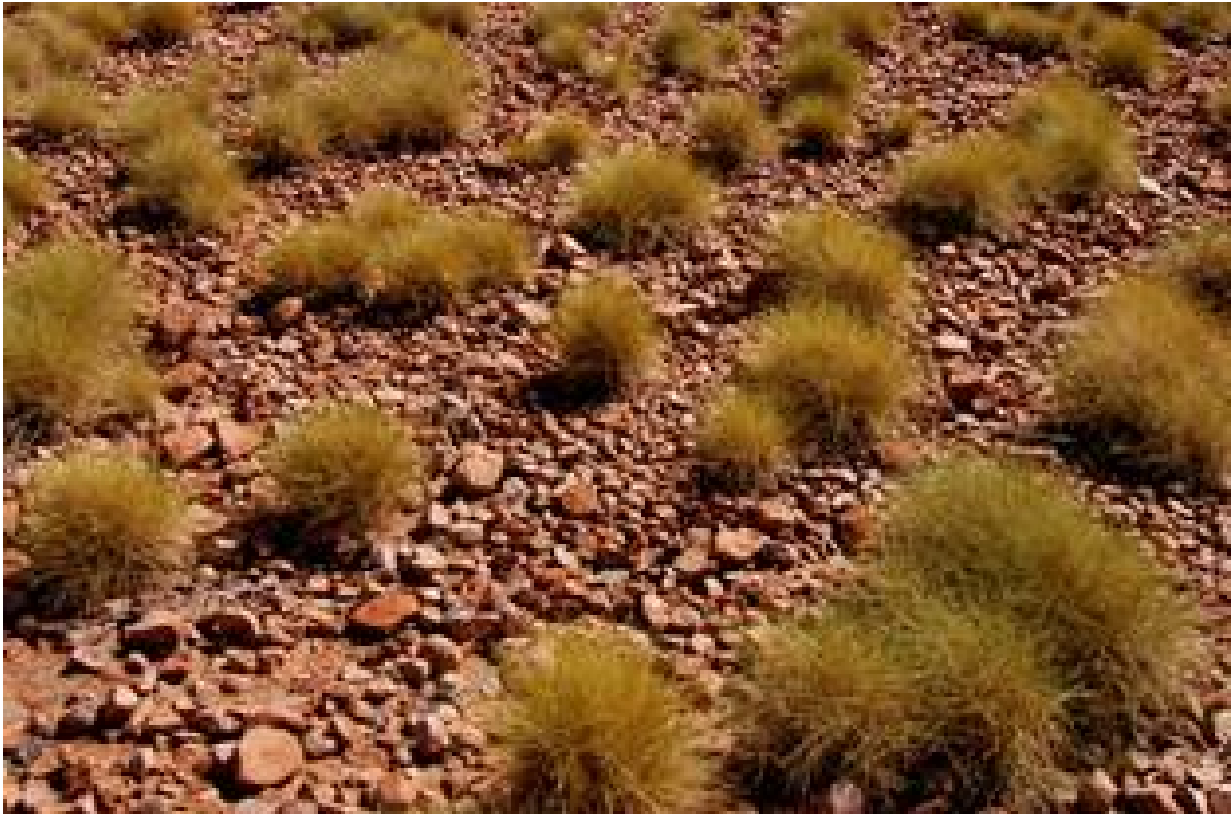
Photograph 8 Typical Undisturbed Hill Landform

Photograph 8 shows an example of an undisturbed hill landform; note the high percentage of ground cover and absence of topsoil on the surface. The above would have far greater erosion resistance properties and is the result that TGNL is aiming to achieve with future rehabilitation. This site will require the ripping of rocks to the surface at the Stage 2 waste dump. This follows the recommendations by Landloch Pty Ltd to improve the erosion resistance of any potentially dispersive wastes

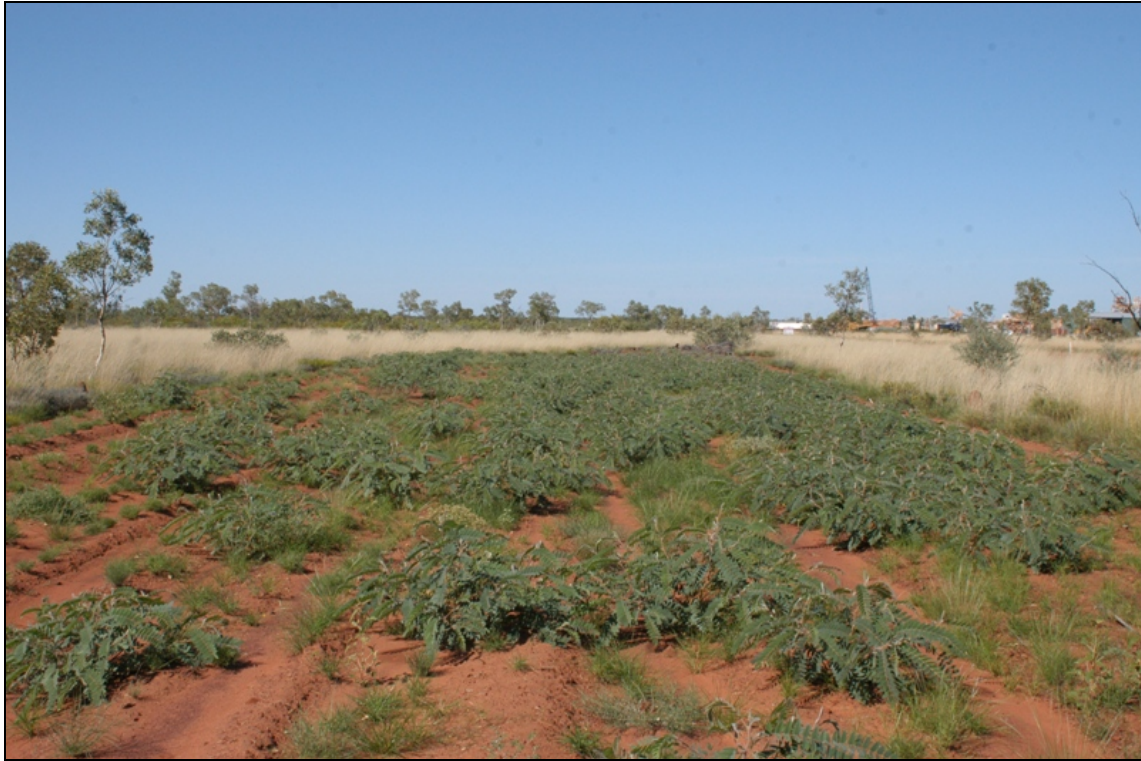
Photograph 9 Example: Long Term Topsoil Stockpile

Cleared vegetation and topsoil have been stockpiled at strategic locations around the mine site. Topsoil has been stripped to a depth of approximately 200mm. Long-term stockpiles are approximately 2m in height and will be deep ripped to enable vegetation growth and continued biological activity (**Photograph 9**). Short-term topsoil stockpiles will be trucked and dumped adjacent to the areas in which they will be used.

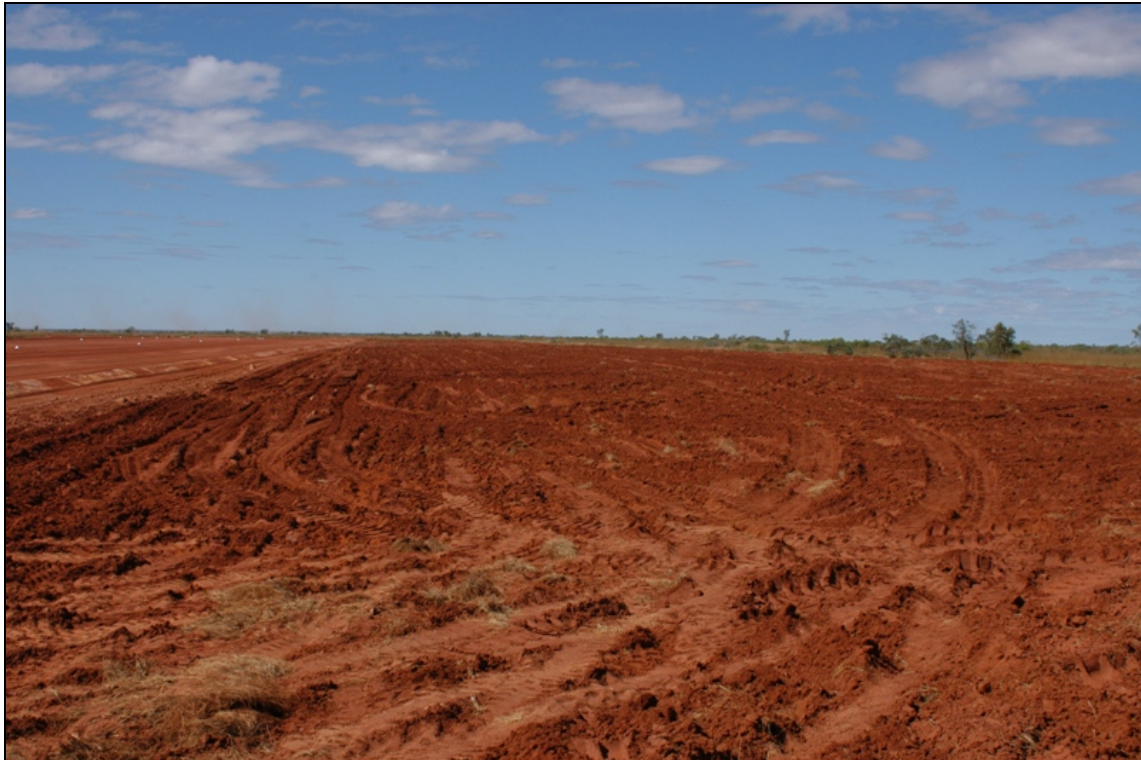
Photograph 10 Example: Airstrip Gravel Pit Rehabilitation

Rehabilitation of site disturbance will be progressive where possible. Rehabilitation of flat areas will involve replacement of topsoil using a grader or bulldozer and deep scarification of the area. There has been no seeding undertaken in any of the areas rehabilitated at Coyote so far and observations have shown good plant diversity. **Photograph 10** and **Photograph 11** show the airstrip gravel pit in May 2006 and April 2007 respectively. The techniques employed for rehabilitation of flat areas appear successful and will therefore continue.
